Vibrational Analysis a Key for Pump Maintenance-Case Study

Abstract: The following case study is the result of the project work and research done by me at one of the major plant in AP. The case study is of a medium pressure water pump which had developed high vibrations. The causes of vibrations were identified using latest non destructive testing tools and corrective measures were implemented. The condition of the pump after the correction was checked and was found within acceptable healthy condition therefore pump was put to use.

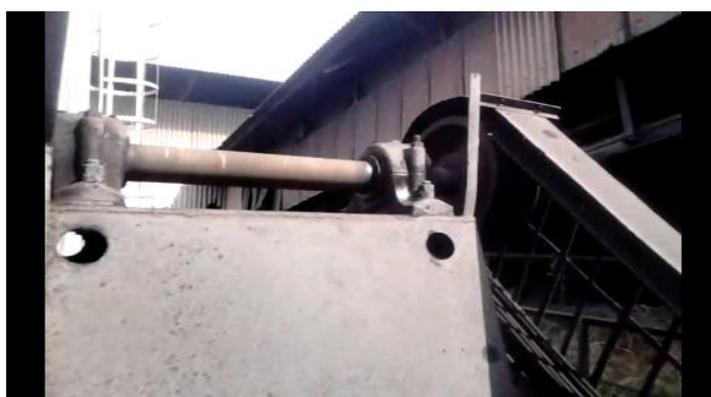
Plummer Block.

The Overall Vibration of PLUMMER BLOCK B3 and B4 were high.

The Horizontal vibration of PB2 reached to a very critical value of 9.8mm/sec

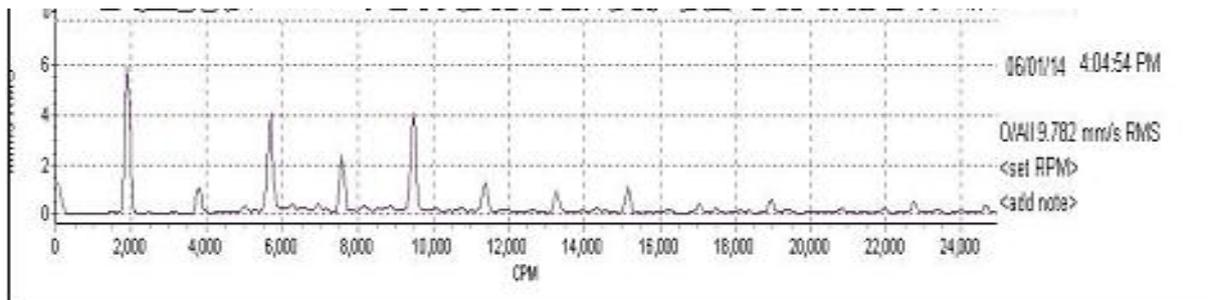
The pump developed looseness due to the bearing clearance which was beyond the limit recommended. On further study it was seen that it also developed misalignment. On through study of spectrum we see that it has developed unbalance also.

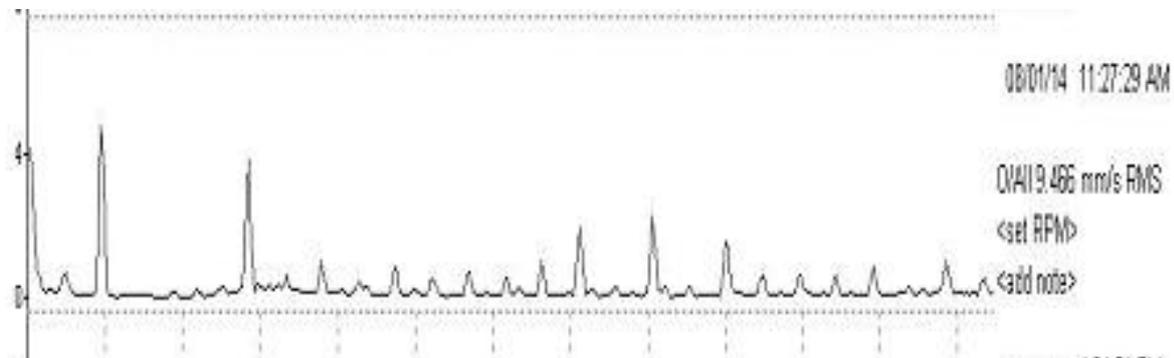
Bearing Clearance:

The peaks 2x, 4x, 5x, 6x indicate mechanical looseness which is due to bearing clearance. The bearing clearance was corrected by the use of shims, due to this correction the rms value has not changed but the peaks 2x, 4x, 5x, 6x etc. vanish, indicating that looseness has been eliminated.

Correction: The bearing was opened and the shaft clearances were measured using precision vernier calipers where it was observed that the clearance was more than the allowed norms. This was corrected by providing an exact size copper shim between the wearing ring and the bearing cover. The bearing clearance was reduced by using shims.

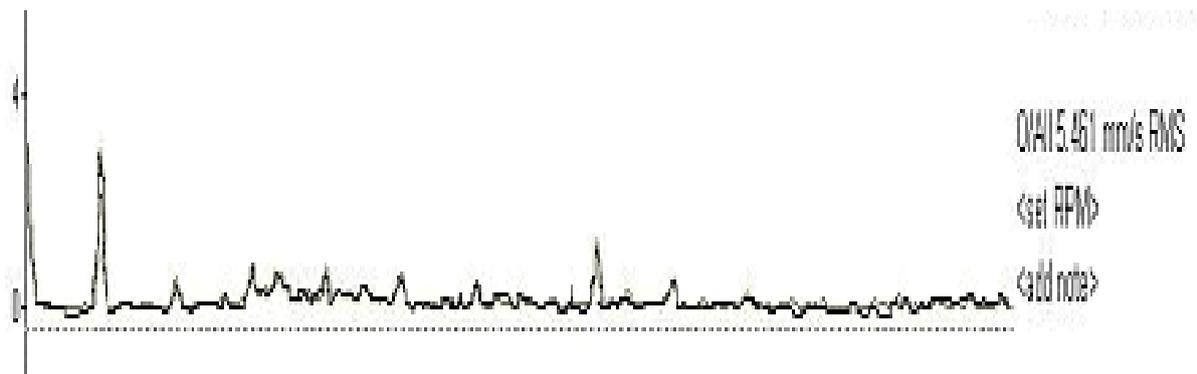
Misalignment:

From the spectrum the peaks 3x, 1x indicate misalignment. So by radial adjustment/alignment of the pump shaft with the pulley shaft was done . By this, the rms value reduced from 9.466 to 6.924 where the peak 3x vanishes and 1x has reduced.

Correction: Misalignment was corrected by correcting parallel misalignment. The pulley shaft was realigned with the pump shaft.

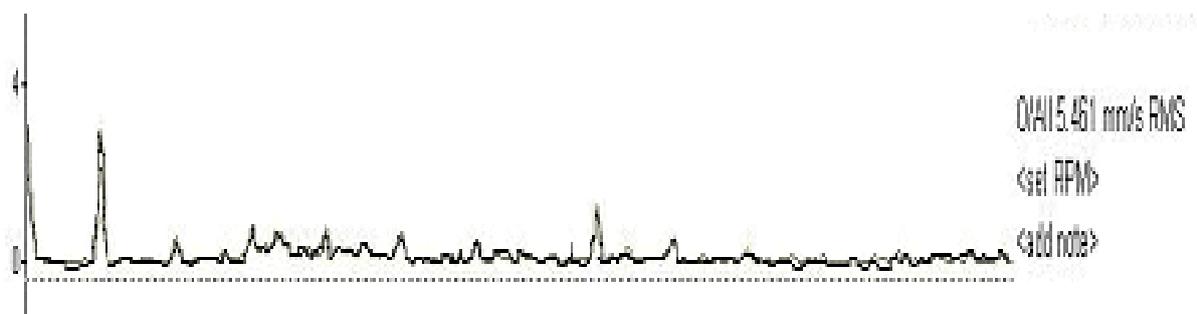
Unbalance:

The Unbalance was corrected. The correction is done by balancing the pulley by adding weight to it. By this, the rms value shifts from 6.924 to 4.0 and the 1x peak vanished. The overall value has come below the norm.

Correction: Unbalance was corrected by adding weights to the pulley which would lead to balancing of equipment.

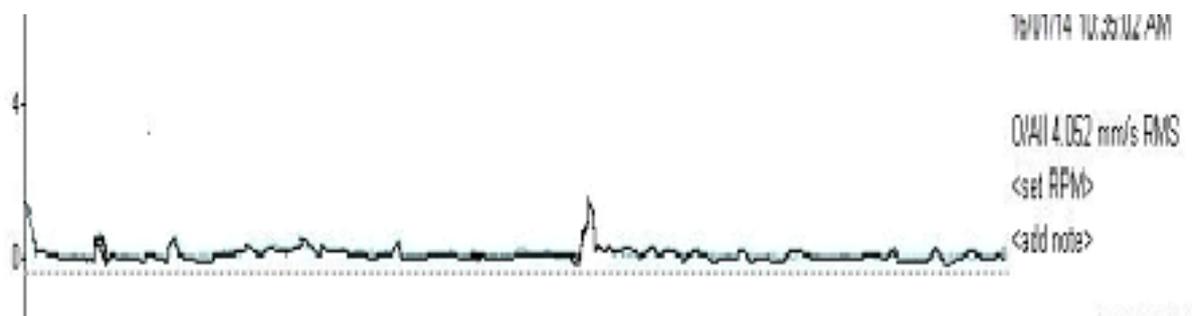
Spectrum of the machine in normal condition (corrected spectrum):

Thus by performing all the above techniques using Condition Monitoring, the Equipment was protected from likely Breakdown.
