Rehabilitation of Reinforced Concrete Building Structurally and Geotechnically

This paper discussed the reasons that cause cracks and slots of buildings through a study of building for commercial studies college at Sudan University of Science and Technology as a case study as well as solutions that were followed to solve cracks problems which appeared in the building.

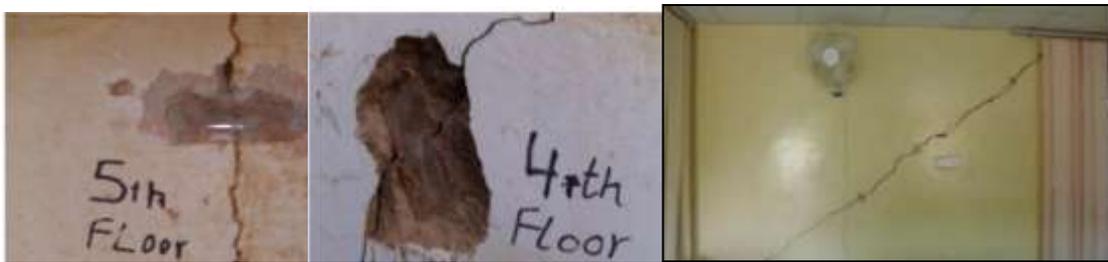
- 1) There are long cracks and springs in the dean's office, electronic library, the internal bathroom of the dean's office, dean's vice office in the first and third storeys in the southern eastern part of the building.
- 2) A collapse of part of false ceiling in those offices as a result of floor movement and walls and their cracks.
- 3) Appearance of cracks also in the third and fourth storeys in the office lying in the southern eastern part of the building.
- 4) The team noticed increase of cracks remarkably during two months.
- 5) Water leaking appeared from drainage network of bathrooms.

Figure 4 shows pictures of the cracks that have occurred in the building at different floors (the eastern and south-eastern part of the building)

There are two types of cracks that occurred in the building, they are vertical cracks and another inclined with angle 45 approximately as mentioned in Table 3. Glass slices were put on the wall in places of cracks to observe them; these slices were fixed by cold welding in perpendicular directions on crack sides during study period (2/6/2013 to 26/6/2013). In case of move cracking, this leads to glass slices to move or breaking them. The slices were daily observed during mentioned period, it was found that they were stabled, but cracks may increase if under land water saturation continues.

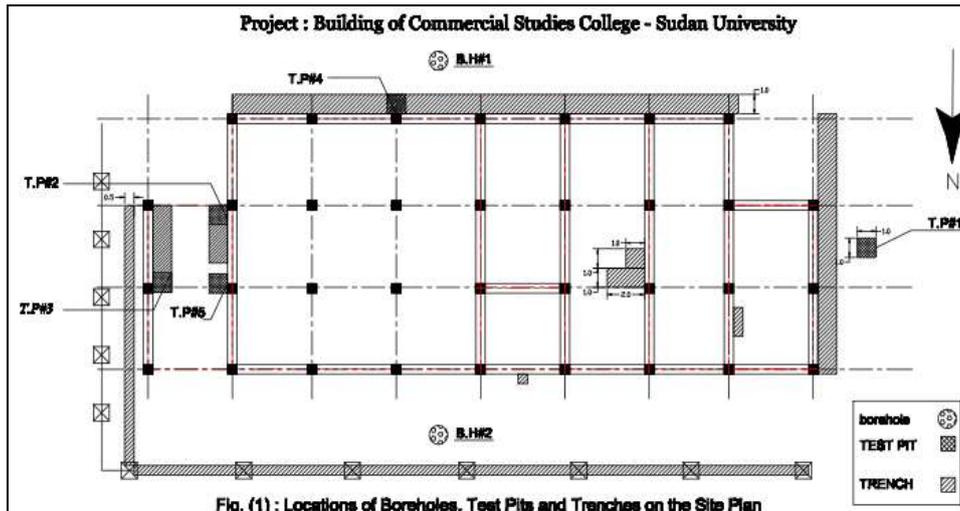
Five manually pits were dug as shown in Table 1 for the purpose of uncovered tests and examining soil layers in nature and taking a photo of it, and uncovering bases to know kind of foundation and depth. Fig.6 shows location of digging. Through describing soil samples and laboratory tests, it was clear that soil layers consist of clay soil with high plasticity.

Figure 6 The plan of building shows the locations of digging

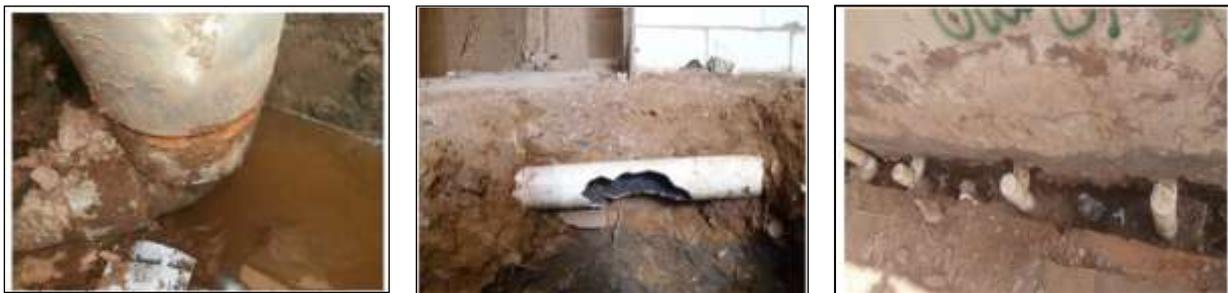
- 1) There was water around toilets which located in distance 1.0 meter south of the building. This water resulted from a break in drainage pipes extending into inspection and leaking room from internal vent vales to supply water. This water caused fall of passage between the building and toilets leading to water running out under the building.

- 2) There are toilets in western part of the building for all storeys; they are drained by the line extending down at the northern-western corner. An apparent break was found at convergence of line extending down with the horizontal line. This led to water leaking under the building.

- 3) The main inspection room was found lying at distance of 2.5 meter from northern-western side and also cracks in its wall and separation of walls from the basis, this leads to water running out under the building especially in case of closing general sewerage pipes.

- 4) It was found also cracks and slots in the inspection room lying west of the building leading to water running out under the building.
- 5) Other breaks were found in drainage line extending from services until in the first and second storey ranging from 15-20 cm. The water of this line flow around the building and the leaking under the building.

Figure.7 some pictures show cracks of drainage pipes leading to water leaking under the building

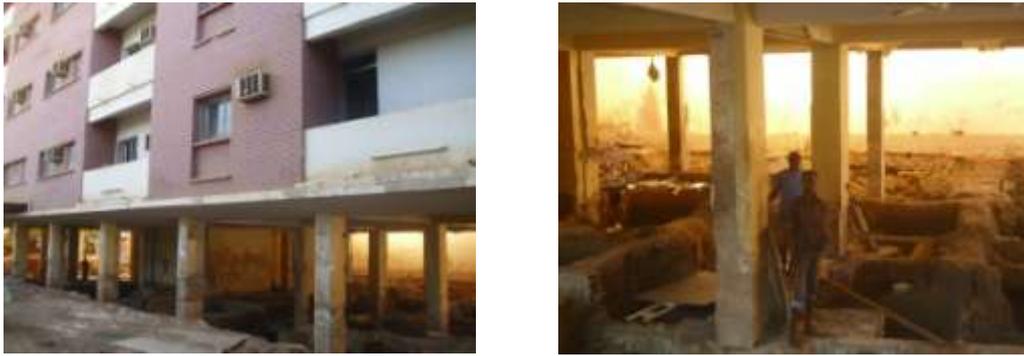
- Effect of water leaking and cracks on the highest piles at the point of joining with the pile cap and some corrosion on the columns as a result of crust or relative settlement or weak happening swelling.
- Appearance of a break in two piles at the columns B-8.
- A hammer test was made for crown concrete and identifying resistance and strength of concrete.
- A test was made to identify resistance of reinforcement steel used and kind of diameters and number and method of distribution.

Figure 8. Pictures of the building during a digging to see the foundation type and water sources under building

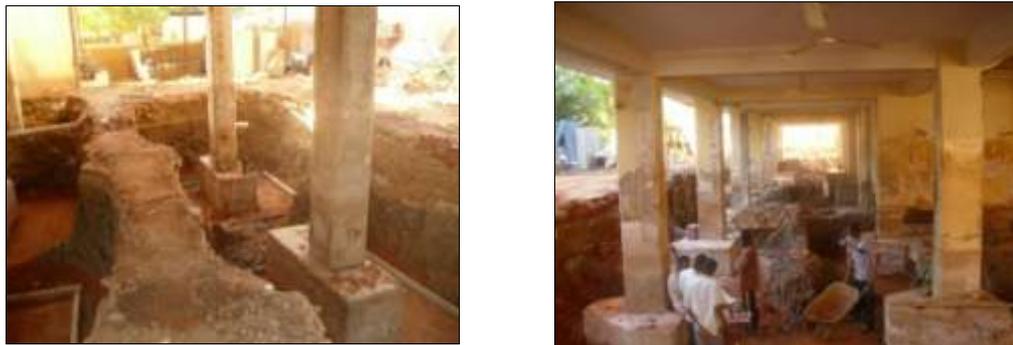
Kind of pile cap	Shape of pile cap	number	Dimension of pile cap	Thickness of pile cap	Depth of footing
1	Semi-triangle	17	0.4x1.7x1.7	0.9	6
2	Rectangle	15	0.7x1.75	0.9	6
3	square	2	0.7x1.7	0.9	6

Figure 9 shows the rectangular and triangular pile caps

12. Triangular pile caps were considered that enlargement will be appropriate for implanting which must be paralleled for reinforcement steel exiting in pile caps.

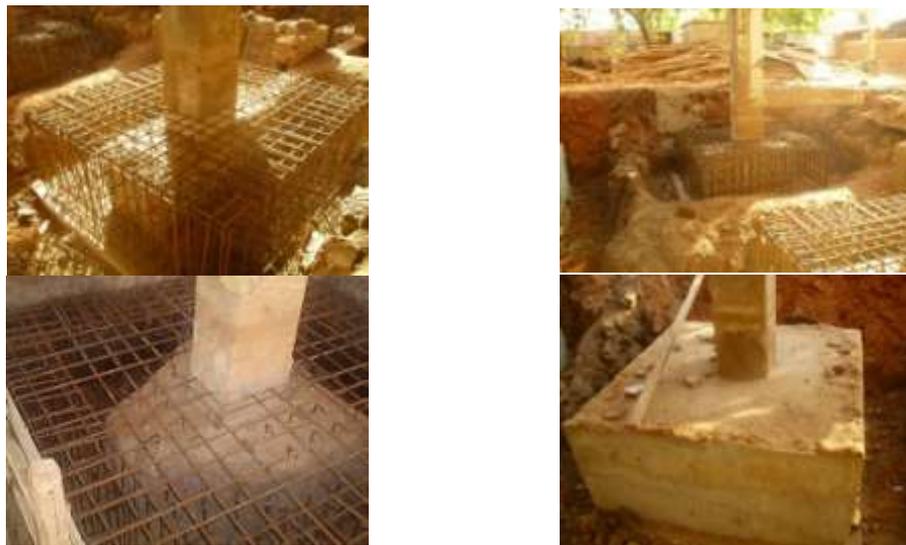
Figure 10 .Shows The Pile Caps Suggestion Rehabilitation System process

Transferring current system of bases to isolated footings and ignoring implemented piles exiting and determined dimension of basis based on soil bearing capacity and allowed settlement and making sure that (one-way shear) and (two-way shear) have no effect at piles and around implemented basis as shown in Figure 10. In case of selecting this suggestion, the following must be checked:

After reviewing design and making structural model for the two mentioned proposals, we found that the best is to transfer current system of footings to completely isolated footings and ignoring exiting implemented piles especially after appearance of fracture in some piles, marking measurement of footing based on soil bearing capacity and allowed settlement after making sure that (one-way shear) and (two-way shear) have no effect at piles and around implemented basis (the exiting pile cap). By using these suggestions and from analysis results we concluded the following:

1. Load combinations were used according to British and European codes.
2. Making all current footings (pile cap) bigger to a basis of (3.00 x 3.00 x 1.00 m) by increasing the current pile cap and implanting steel bar 16mm diameter and 13 cm space and fixing by epoxy and bottom and top reinforcement $\phi 16 @ 15 \text{ mm c/c}$ in the two directions as shown in Figure. 10.
