Experimental Investigation and Failure Analysis of helical pinion shaft in WAG-9 Locomotive

C.B. Chaudhari¹, Dr. R. N. Baxi²

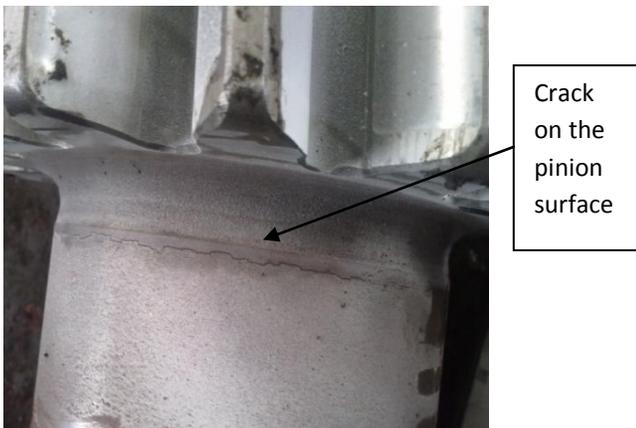
The helical pinion shaft material is made up of forged steel (DIN 17182 -17CrNiMo4) [2]. In this proposed study the failure investigation of the crack formed at notch region (figure4) and premature failure of the shaft of the helical pinion is discussed in details.

Figure 4 Failure Component Helical pinion with crack on the surface

- 1) To conduct stress analysis of the helical pinion
- 2) The design aspects such as sudden change in design (notch region in this case) also should be taken in to consideration for analysis.

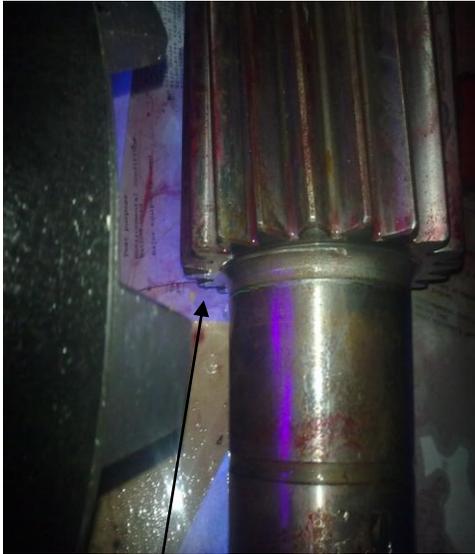
Fig 5 Helical pinion

The magnetic particle (magna flux) inspection method is used to detect cracks, laps, seams, inclusions and other types surface of near surface discontinues in ferromagnetic materials. Typically, we used magnetic particle inspections to find fatigue induced surface and near surface cracks in helical pinion parts. For carrying out the test the fluorecent powder mixed in liquid is spread on the pinion surface. At the same time pinion is magnetized with instrument and ultraviolet light is focused on it. The image below shows the typical crack lining along circumference of pinion shaft.

Crack detected on the surface by Magnetic particle test

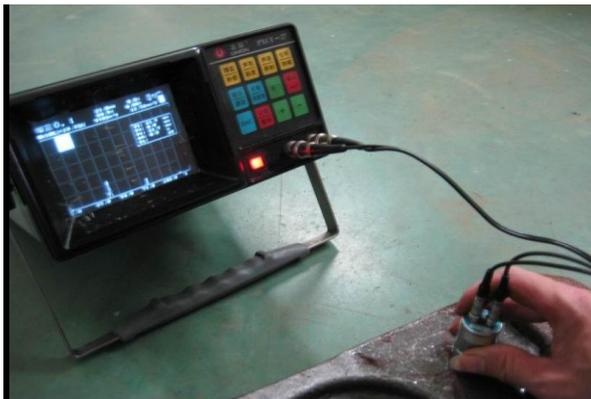
Fig 6 Ultrasonic test

With the ultrasonic test a crack is detected on the surface of the pinion shaft at a depth of 25-30mm

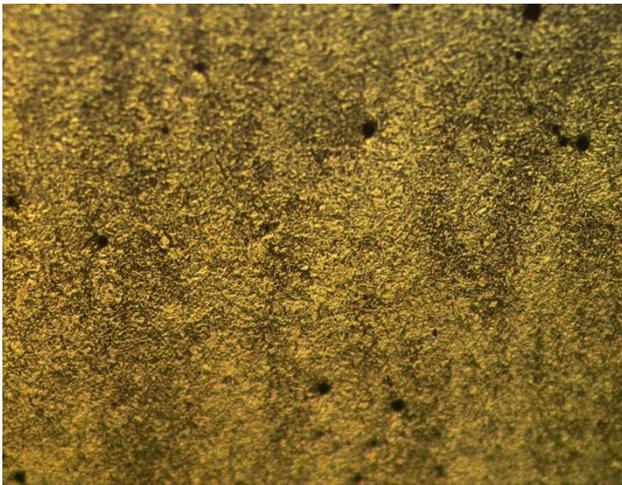
Figure:7 Metallograph of the failure component of the Helical pinion shaft. X100.

1. Almost 30 % region in the microstructure shows Carbide phase (Fe_3C) with ferrite background.
2. The metallographic analysis can be very well correlated with the chemistry of the component. The observation as per the microscopic examination gives clear-cut indication of higher carbon content in the material, although specified value of the carbon is 0.20%.
