Displacement in Load Bearing Straw Bale Walls Due To Concentric Compressive Loading

Gihan L. K. Garas, Mostafa E. Allam, Ahmad K. Abdel Gawad,
Mohamed Abdel Moneim

Civil Engineering Department, National Research Center, Cairo, Egypt

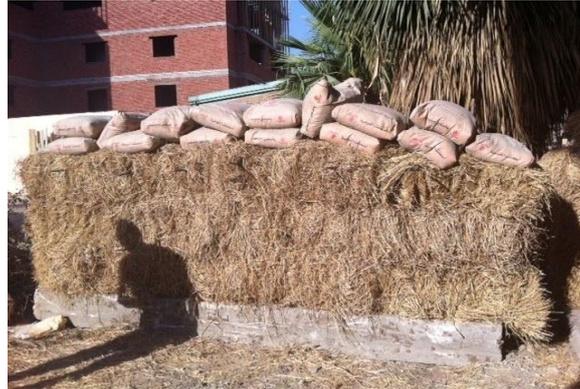
Figure 2: Pre-compression Test of full scale wall A

A pre-compression test Fig. 2 was undertaken on wall A by applying one ton of cement bags on top of the bales of the tested wall directly and left for 5 days before plastering. The observed settlement just after loading is shown in Table 1 measured by the Leveling procedure.

Five points are fixed at the tested rice straw wall using steel bars fixed through the wall width. Also, one control point is fixed at a nearby building out of the loading area. From the control point, the levels of the five points can be computed. The vertical movement (deflection) of point (T), between any two vertical positions (I and J), comes from two loading cases, can be computed by subtracting the two levels of point (T) as indicated in equation (1).

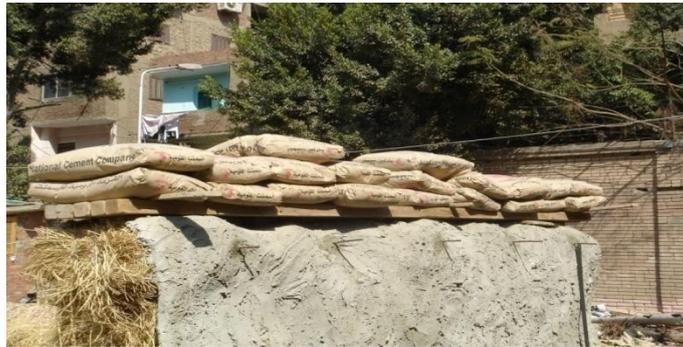
Figure 4: The 2nd loading case after plastering the wall

After releasing the pre-compression load, a steel wire mesh was used to cover wall A from top and both sides before the plastering application. Cement plastering then took place for the wall and left for curing and drying for a period of 28 days before testing. On top of the bales in wall A another set of cement bags for loading were applied regularly. These cement bags were laid on a wooden platform along the length of the wall. The leveling technique was used to measure the settlement in the wall. The used surveying instruments in the experiment were calibrated and adjusted before using them. The control and target points were observed using the level, and the scale readings were recorded before loading, then after applying 1 ton of loads and finally after applying 2 tons of loads. Fig. (3) & (4) show the position of the monitored points as well as the dimensions of the wall.

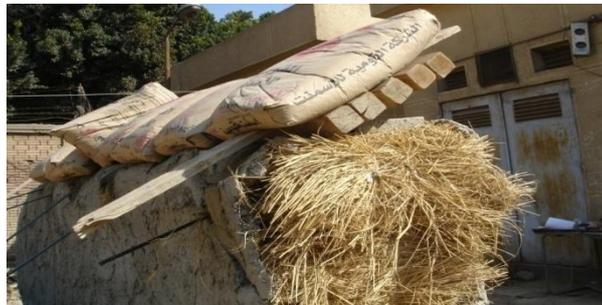
Figure 5: Failure point of loading

The test never ended up till this point of loading as the plan was to keep loading the wall until we reach the failure point as shown in Fig. 5. The failure point was reached after applying over 2.5 tons of cement bags on top of the wall.

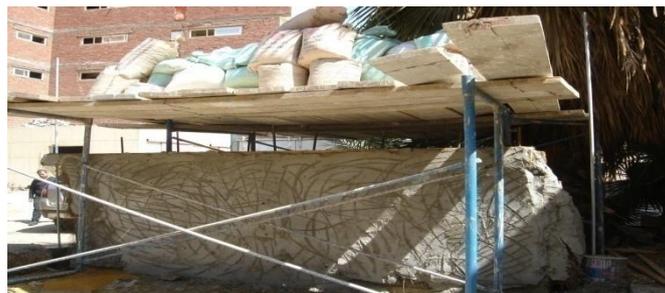
Figure 6: The loading technique on Wall B

This wall was plastered in a slightly different way from wall A where the top wooden cap plate was inserted on top of the bales then the wire mesh and plaster were applied. This procedure was undertaken to insure more load uniformity over the wall and to avoid the catastrophic failure seen of wall A. The loads were distributed on a wooden platform erected 35cm above the top wooden plate of the wall as shown in Fig. 6. Then 2 hydraulic jacks were set between the wooden platform carrying the load and the top wooden plate of the wall to transfer the loads gradually to the wall. Also 2 LVDTs were connected to the hydraulic jacks to record the settlement in the wall as shown in Fig. 7.

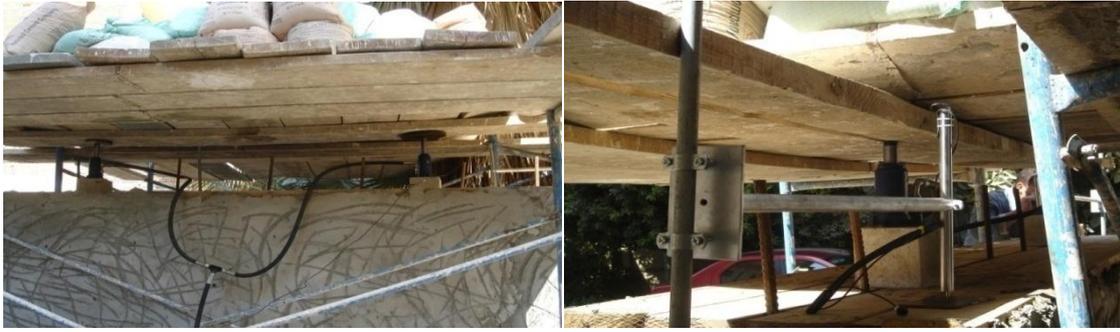
Figure 7: The connection between the Hydraulic Jacks and the LVDTs on Wall B
