Vibrational Analysis a Key for Pump Maintenance-Case Study

Abstract: The following case study is the result of the project work and research done by me at one of the major plant in AP. The case study is of a medium pressure water pump which had developed high vibrations. The causes of vibrations were identified using latest non destructive testing tools and corrective measures were implemented. The condition of the pump after the correction was checked and was found within acceptable healthy condition therefore pump was put to use.

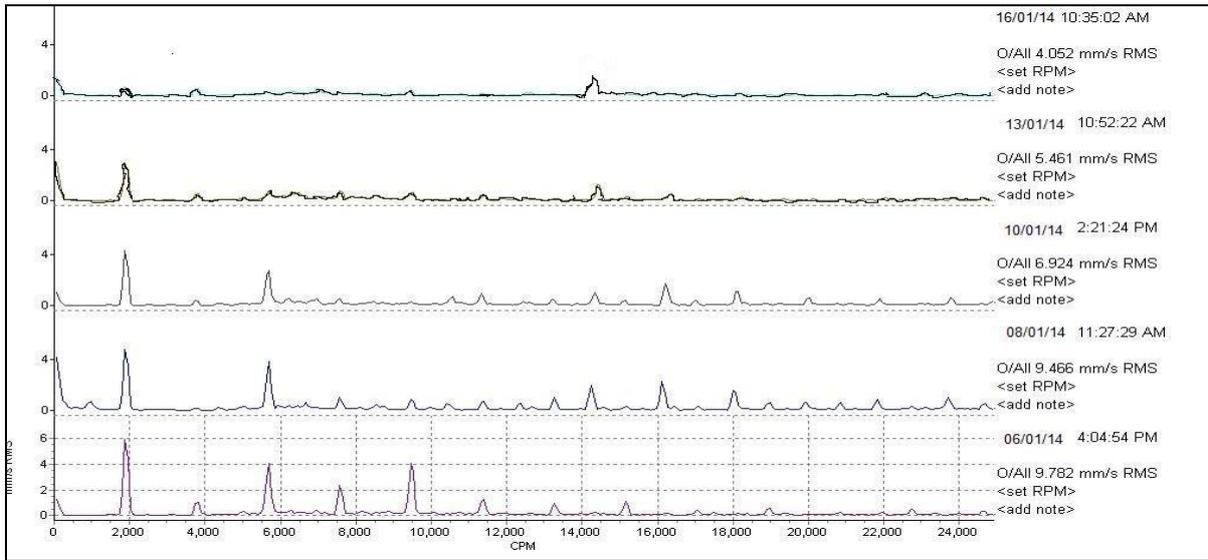
SPECTRUM ANALYSIS:

The pump developed looseness due to the bearing clearance which was beyond the limit recommended. On further study it was seen that it also developed misalignment. On through study of spectrum we see that it has developed unbalance also.

The peaks 2x, 4x, 5x, 6x indicate mechanical looseness which is due to bearing clearance. The bearing clearance was corrected by the use of shims, due to this correction the rms value has not changed but the peaks 2x, 4x, 5x, 6x etc. vanish, indicating that looseness has been eliminated.
