Experimental Investigation and Failure Analysis of helical pinion shaft in WAG-9 Locomotive

C.B. Chaudhari¹, Dr. R. N. Baxi²

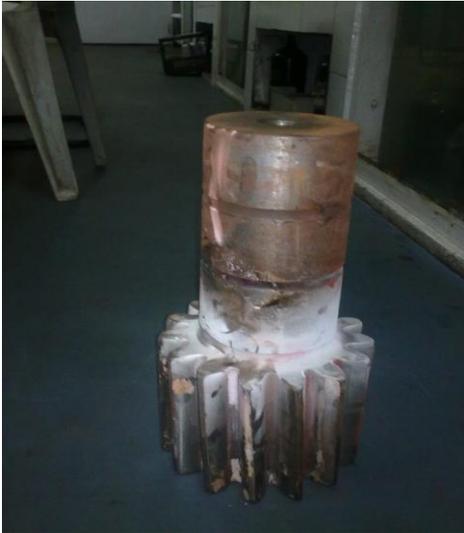
Figure3: Helical pinion of traction motor

The helical pinion shaft material is made up of forged steel (DIN 17182 -17CrNiMo4) [2]. In this proposed study the failure investigation of the crack formed at notch region (figure4) and premature failure of the shaft of the helical pinion is discussed in details.
